Transom/Bailer Unit Seating Repair

Repair of transom around the perimeter of the self bailer units due to incorrect manufacture, deterioration or rot, which would otherwise result in water leakage into the double bottom of hull and accelerated deterioration of the wood transom board

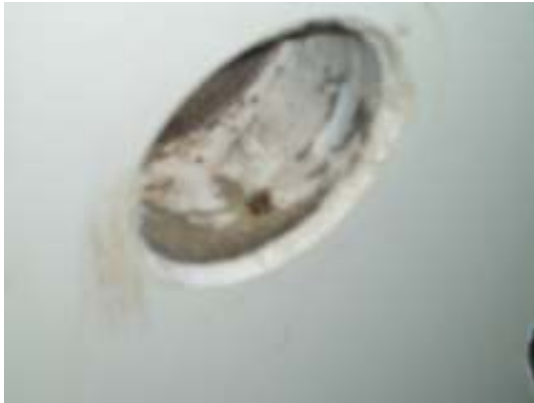
Fig 1 Loose surface compound

- 3.1 Remove the self bailer units by removing the retaining unit and gently tap out the unit with a soft mallet whilst removing any sealer compound
- 3.2 The surface perimeter of the bailer mounting hole will be cleared of loose surface compound, paint or Gel coat by using a blunt edge.

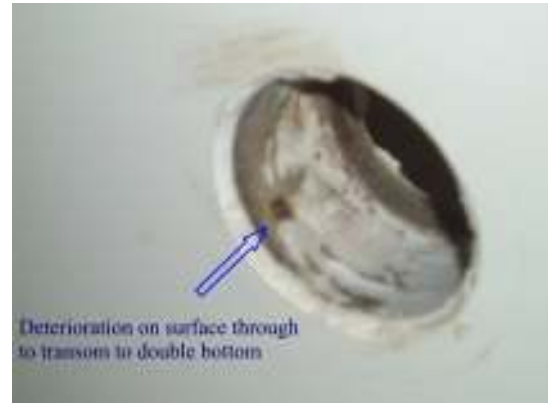
Fig 2 Rot & deterioration

- 3.3 The surface perimeter of the bailer mounting hole is to be inspected for deterioration and rot.
- 3.4 The surface of the bailer mounting hole is to be lightly sanded with a fine 180 grit abrasive paper in preparation for applications.

- 3.5 Any areas of rot are to be removed and thoroughly cleaned with acetone.
- 3.6 The surface will be thoroughly cleaned with acetone in preparation for wood grade marine resin

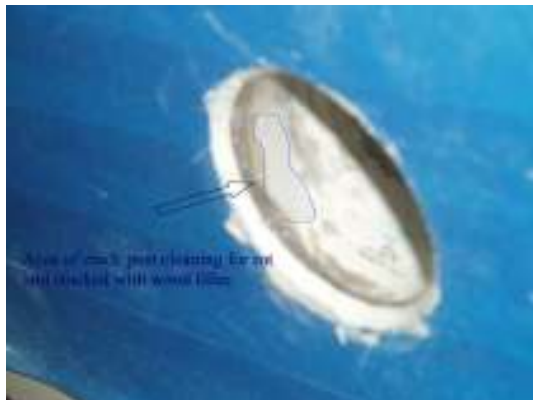
Fig 3 Wood grade marine resin applied

- 3.7 A mixture of wood grade marine resin/hardener compound is prepared homogenously and applied to fill the defective area or crevice opening, ensuring that afflicted area is completely filled. (It is best to test out the product for effective hardening prior to application to confirm its effectiveness)

- 3.8 The wood resin compound will require a minimum of 3-6 hours curing time until it hardens satisfactory.
- 3.9 The hardened resin is then sanded down using a medium 100grit sand paper to remove any peaks to uniformity.

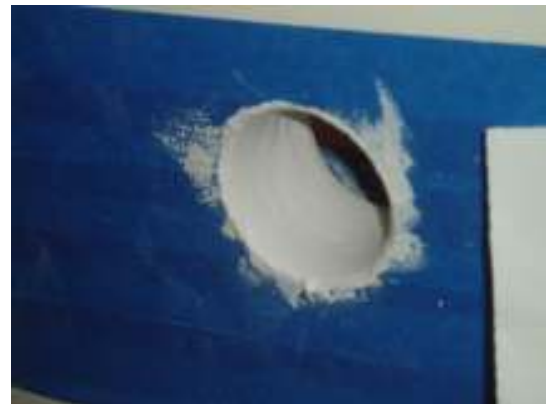
Fig 4 – Gel coat application

- 3.10 Gel coat and hardener will then be prepared against manufacturer's recommendations and applied to the surface of the bailer mounting hole and allowed to dry.

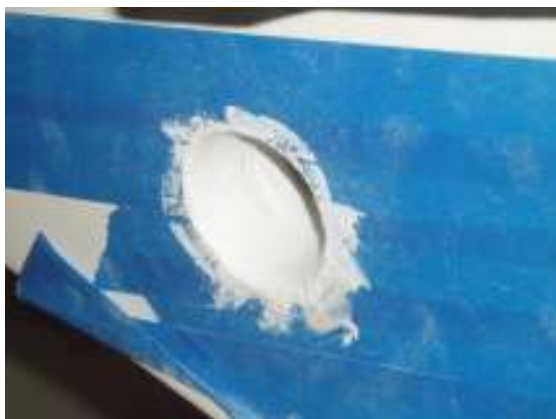
Fig 5 – Gel coat sanded to uniformity

- 3.11 The use of a hot air dryer is recommended in Gel coat applications post curing as the surface may remain slightly tacky
- 3.12 The cured Gel coat will be sanded down once again using a combination of Medium 100 grit and fine 180 grit sandpaper to obtain a correct fit with the self bailer barrel, retaining a uniform of 0.5 - 0.8mm thickness.

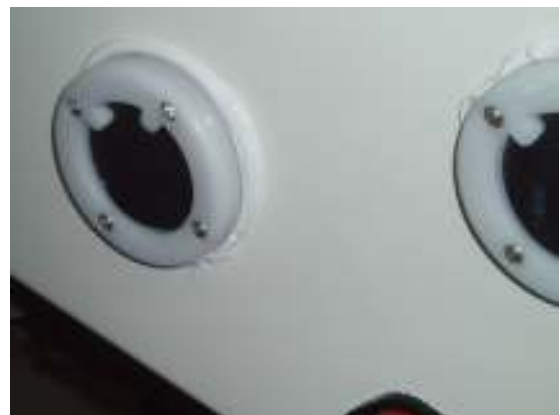
Fig 6 – Bailer unit mounted and sealed

- 3.13 Marine grade silicone compound is to be applied liberally on the seating flange on the self bailer unit
- 3.14 Remove the blue masking tape from the stern side of the transom.

- 3.15 The self bailer will be inserted and secured by lightly tapping the end with a rubber mallet until a secure bond with the transom is achieved.
- 3.16 Remove the blue masking tape from the transom on the deck side.

- 3.17 Marine grade silicone compound is to be applied liberally on the seating flange on the lock nut
- 3.18 The self bailer unit is then secured by hand tightening the locknut + a quarter turn to effect final pressure. (the front end of the bailer unit may need to be held to restrict rotation whilst fastening.
